**Flood Control Project Maintenance
Levee Inspections**

Fall 2018 Levee Maintenance Deficiency Summary Report

**Flood Control Project Maintenance
Levee Inspections****LMA District Cover Sheet
Fall 2018 Levee Inspection Results****Sacramento River West Side Levee District**

Sacramento River West Side Levee District

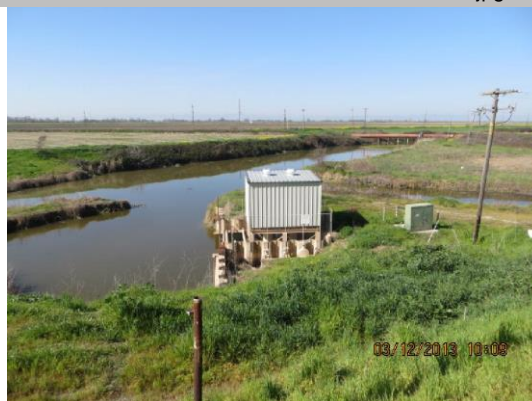
Photo 1 of 3 : UCIP_FA_2018_10085_17227.jpg

Pump house on LS toe.

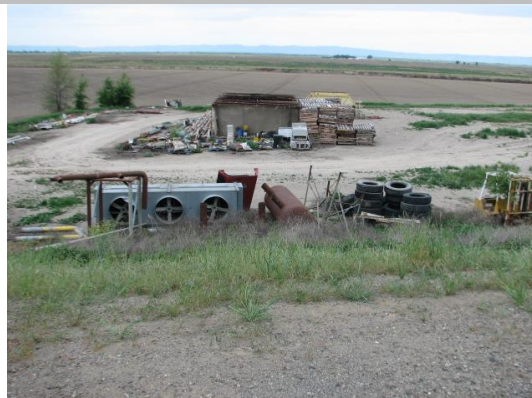
Photo 1 of 2 : FA_2018_NA0016_435_1550_20180904_00057.jpg

Pieces of machinery and debris at the levee toe. Spring 2014

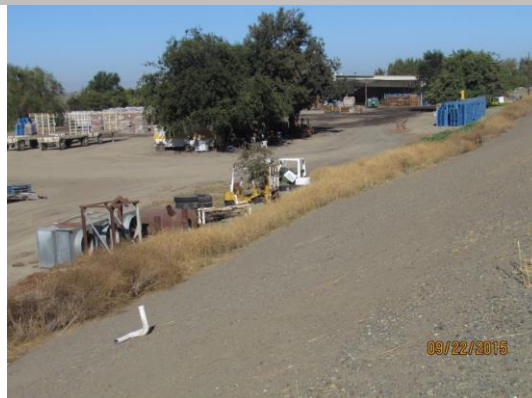
Photo 2 of 2 : FA_2018_NA0016_435_1550_20180904_00058.jpg

View of the machinery along the landward levee toe looking upstream.
Fall 2015.

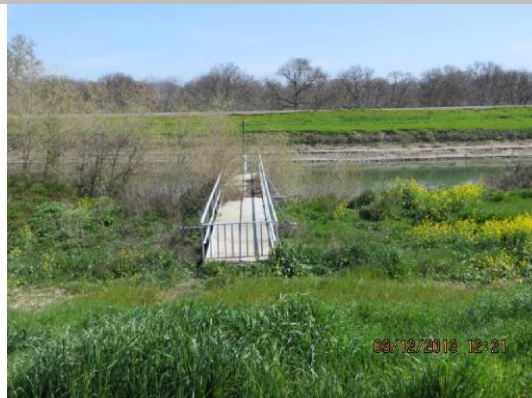
Photo 1 of 3 : UCIP_FA_2018_10125_17283.jpg

Steel walkway on WS berm with Slide gate actuator.

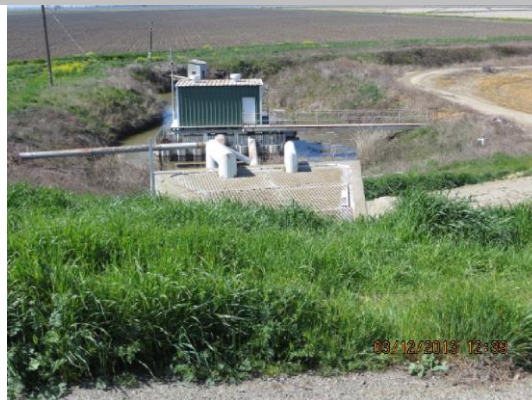
Photo 2 of 3 : UCIP_FA_2018_10125_17282.jpg

Pumphouse at LS toe and concrete riser on LS shoulder.

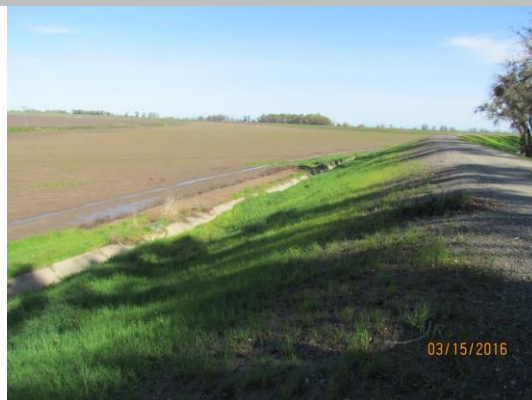
Photo 1 of 1 : FA_2018_NA0016_435_8_20180904_00001.jpg

LM Start	3.56	Rating **	M	Issue No.	8
LM End	3.94	Issue Type +	En	Location *	LS
Category	Earthen Levee			GPS Latitude/Longitude	
				Start	End
Item	Encroachments			38.846785 °	38.850758 °
				-121.729995 °	-121.725263 °
DWR ID	DWR_NA0016_01_s_2012_8				
Comment Code					
DT : Ditch					
Inspector Comment					
Concrete lined ditch runs along the levee toe.

View of the ditch on the landward side of the levee looking upstream.
Spring 2016.

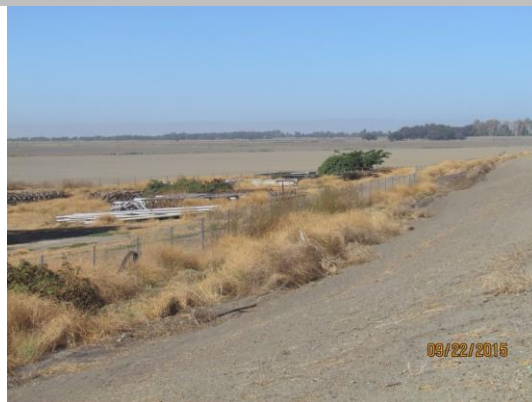
Photo 1 of 1 : FA_2018_NA0016_435_9_20180904_00002.jpg

LM Start	4.80	Rating **	M	Issue No.	9
LM End	4.80	Issue Type +	En	Location *	LS
Category	Earthen Levee			GPS Latitude/Longitude	
				Start	End
Item	Encroachments			38.859446 °	38.859446 °
				-121.732774 °	-121.732774 °
DWR ID	DWR_NA0016_01_s_2012_9				
Comment Code					
FE : Fence					
Inspector Comment					
chain link fence runs along levee

View of the chain link fence along the landward levee toe looking upstream. The fence does not obstruct the view. Fall 2015.

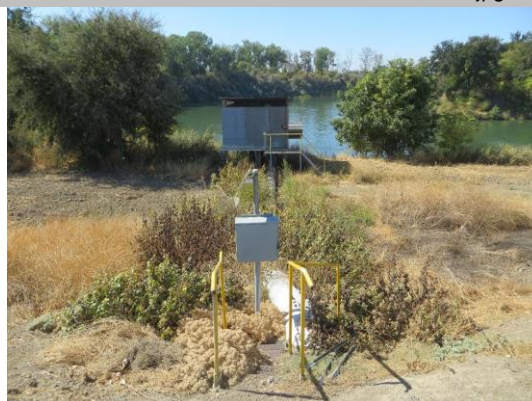
Photo 1 of 3 : UCIP_FA_2018_46766_74705.jpg

view from levee crest along pipe looking towards water side. shows pipe daylight and pump house

Comment Code						
Inspector Comment						
FS_ID:46766 DS_ID:25126 EP_NO: 8501 Repair Type: Non-Urgent Crossing Status: Found UCIP Comments: a few actions are recommended based on field inspection: 1. clear out metal fence posts near daylight of pipe on water side levee. 2. clear vegetation around pipes on water side of levee to aid in inspection. 3. monitor burrowing activities on water side of levee. FIELD_STRUCT_DESC: 2 of 2: 20-inch steel irrigation pipe, at an unknown depth, and 16-inch steel irrigation pipe, at an unknown depth, are located at levee mile 6.889 and 6.89, respectively. Both pipes have a protective paint coating. The pipes are used to supply irrigation water to the adjacent fields. On the waterside (WS) of the levee, the pipes are above ground and follow the slope of the bank into the river. A metal pump house, supported on a steel frame, is located on a bench on the WS of the levee. When the pumps are operational, a drum fish screen is lowered over the pipe intakes on a track. Both irrigation pipes travel through the levee and have siphon breakers inside corrugated metal riser units on the landside (LS) crest of the levee. The pipes discharge under submerged conditions to a 9.5-foot by 12-foot concrete distribution box. There are two gated outlets on the distribution box that lead to distribution canals. FS Date: 10/9/2015

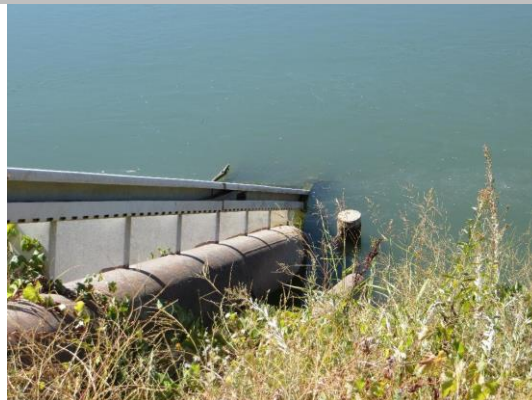
Photo 3 of 3 : UCIP_FA_2018_46766_74707.jpg

pipe intake in river. shows pipes entering water and track for drum fish screen.

Comment Code						
Inspector Comment						
FS_ID:46766 DS_ID:25126 EP_NO: 8501 Repair Type: Non-Urgent Crossing Status: Found UCIP Comments: a few actions are recommended based on field inspection: 1. clear out metal fence posts near daylight of pipe on water side levee. 2. clear vegetation around pipes on water side of levee to aid in inspection. 3. monitor burrowing activities on water side of levee. FIELD_STRUCT_DESC: 2 of 2: 20-inch steel irrigation pipe, at an unknown depth, and 16-inch steel irrigation pipe, at an unknown depth, are located at levee mile 6.889 and 6.89, respectively. Both pipes have a protective paint coating. The pipes are used to supply irrigation water to the adjacent fields. On the waterside (WS) of the levee, the pipes are above ground and follow the slope of the bank into the river. A metal pump house, supported on a steel frame, is located on a bench on the WS of the levee. When the pumps are operational, a drum fish screen is lowered over the pipe intakes on a track. Both irrigation pipes travel through the levee and have siphon breakers inside corrugated metal riser units on the landside (LS) crest of the levee. The pipes discharge under submerged conditions to a 9.5-foot by 12-foot concrete distribution box. There are two gated outlets on the distribution box that lead to distribution canals. FS Date: 10/9/2015

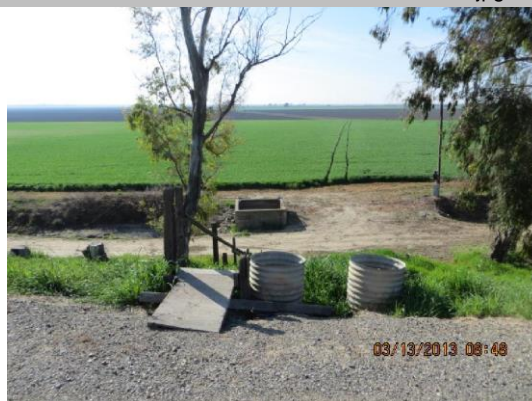
Photo 1 of 3 : UCIP_FA_2018_10144_17307.jpg

Stairs, distribution box, and air vent in CMP riser on LS.

Comment Code						
Inspector Comment						
FS_ID:10144						
DS_ID:20428						
EP_NO: 18206						
Repair Type: Non-Urgent						
Crossing Status: Found						
UCIP Comments: Flap gates rusted through at concrete distribution box on LS toe.						
FIELD_STRUCT_DESC: 1 of 2: 20-inch steel irrigation pipe through the levee, 4.7 feet below the crown. Slant pump inside pump house on the waterside (WS) berm. Siphon breaker inside corrugated metal riser unit on the shoulder. Flap gate on pipe inside concrete distribution box on the landside (LS). Wooden steps on both slopes. (Permit No. 18206, 2007 - River Garden Farms). (Replaced 20-inch pipe installed under Permit No. 9377, 1974 - Faye Properties, Inc.). [Additional Reference(s): DWR Levee Log, 2006].						
FS Date: 3/13/2013

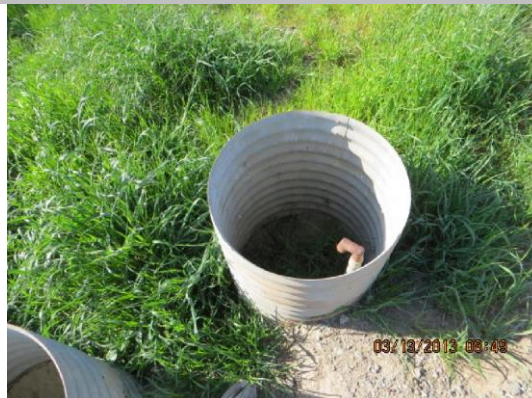
Photo 3 of 3 : UCIP_FA_2018_10144_17305.jpg

Air vent in CMP riser on LS shoulder.

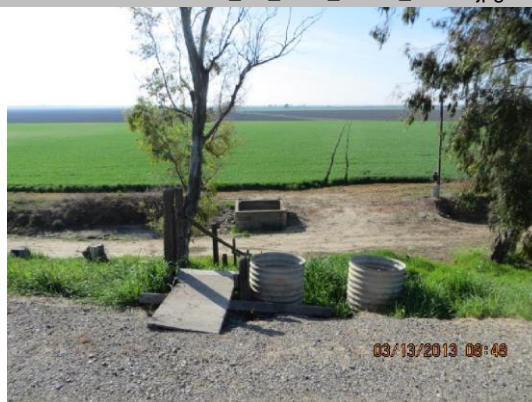
Photo 1 of 3 : UCIP_FA_2018_10143_17302.jpg

Comment Code						
Inspector Comment						
FS_ID:10143 DS_ID:20427 EP_NO: 18206 Repair Type: Non-Urgent Crossing Status: Found UCIP Comments: Flap gates rusted through at LS distribution box. FIELD_STRUCT_DESC: 2 of 2: 16-inch steel irrigation pipe through the levee, 4.7 feet below the crown. Slant pump inside pump house on the waterside (WS) berm. Siphon breaker inside corrugated metal riser unit on the shoulder. Flap gate on pipe inside concrete distribution box on the landside (LS). Wooden steps on both slopes. (Permit No. 18206, 2007 - River Garden Farms). (Replaced 16-inch pipe installed under Permit No. 9377, 1974 - Faye Properties, Inc.). [Additional Reference(s): DWR Levee Log, 2006]. FS Date: 3/13/2013

Steps, air vent in riser, and distribution box on LS.

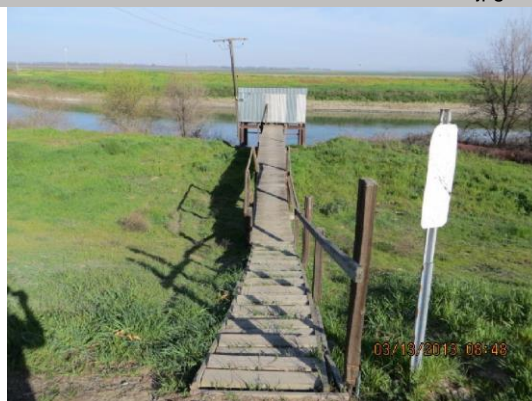
Photo 2 of 3 : UCIP_FA_2018_10143_17301.jpg

Stairs, pump platform on WS.

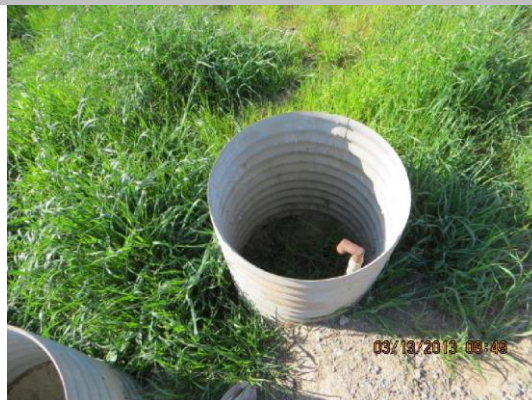
Photo 3 of 3 : UCIP_FA_2018_10143_17300.jpg

Vent in riser on LS shoulder.

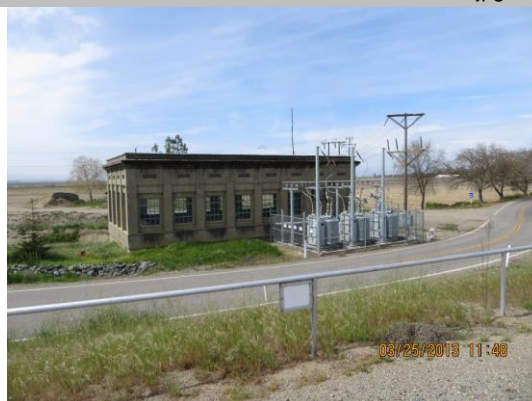
Photo 1 of 3 : UCIP_FA_2018_10146_17312.jpg

Pumphouse on LS toe.

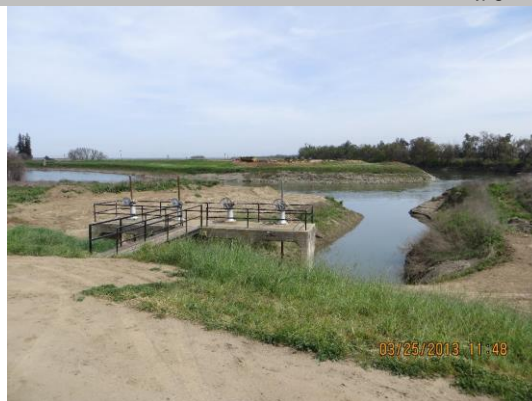
Photo 2 of 3 : UCIP_FA_2018_10146_17311.jpg

Walkway to slide gate actuators on WS shoulder.

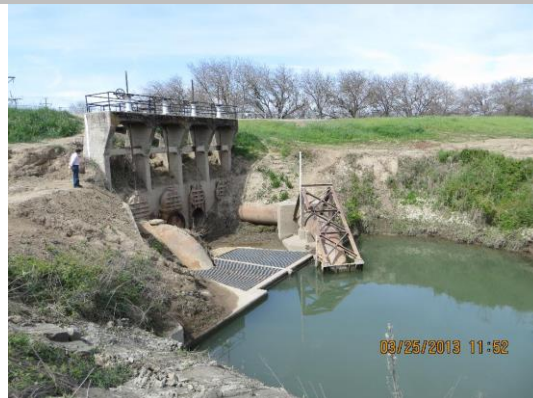
Photo 3 of 3 : UCIP_FA_2018_10146_17310.jpg

Pipes at outlet on WS toe.

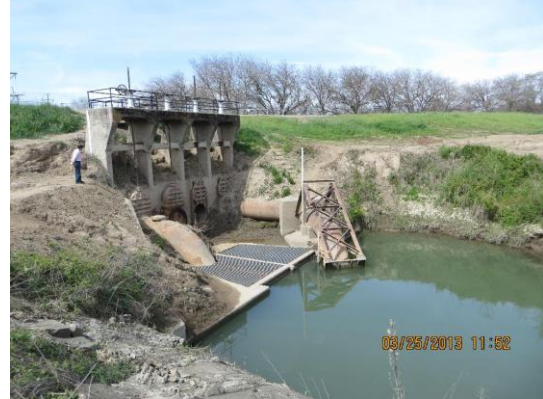
Photo 3 of 3 : UCIP_FA_2018_10148_17318.jpg

Pipes at outlet on WS.

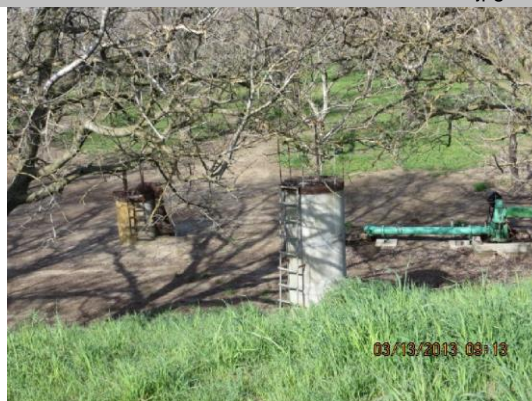
Photo 1 of 3 : UCIP_FA_2018_50039_17328.jpg

Concrete riser on LS toe.

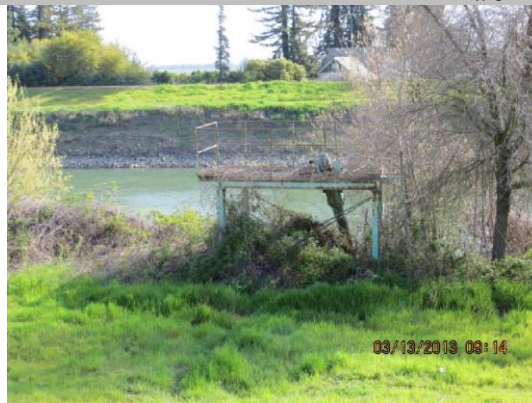
Photo 2 of 3 : UCIP_FA_2018_50039_17327.jpg

Pump platform on WS.

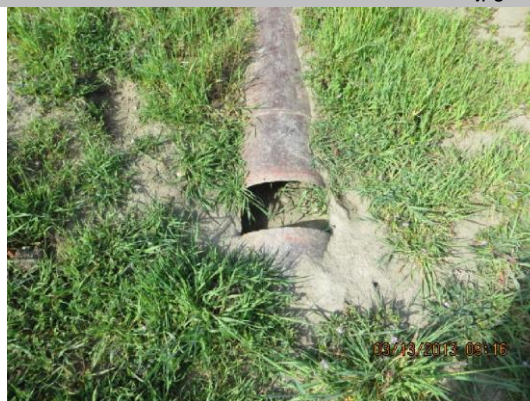
Photo 3 of 3 : UCIP_FA_2018_50039_17326.jpg

Comment Code						
Inspector Comment						
FS_ID:50039 DS_ID:20231 EP_NO: 1641 Repair Type: Non-Urgent Crossing Status: Found UCIP Comments: 09/23/2016 - pipe is not actively used. No power to pump platform. vegetation growth obscuring view along pipe alignment on the WS toe (T.Hatch/UCIP) 09/01/2016 pipe is visible on the WS slope of the levee. The pipe appears intact on the WS and does not appear to have a meter. The siphon breaker on the LS slope appears to have been removed and replaced by a cap. No holes or missing connections were visible. WS levee slope appears to have a slight depression in the vicinity of the exposed pipe. (T. Hatch/UCIP) 03/13/2013 - Meter removed from the pipe on the WS and pipe is open. Pipe appears abandoned, and, if so, should be abandoned properly. (W. Wylie/UCIP) FIELD_STRUCT_DESC: *ABANDONED* 14-inch steel irrigation pipe through the levee, 5.2 feet below the crown. Slant pump on a concrete pump platform on the waterside (WS). Siphon breaker on the landside (LS) slope. Sparling flow meter on the pipe on the WS slope. 42-inch concrete standpipe in a concrete distribution box at the landside (LS) toe. (Permit No. 1641, 1952 - William Erdman Jr.). [Additional Reference(s): DWR Levee Log, 2006. USACE Sacramento O&M Manual 130, May 1960 (HLM 9.31)]. FS Date: 9/23/2016

Pipe open where watermeter was removed.

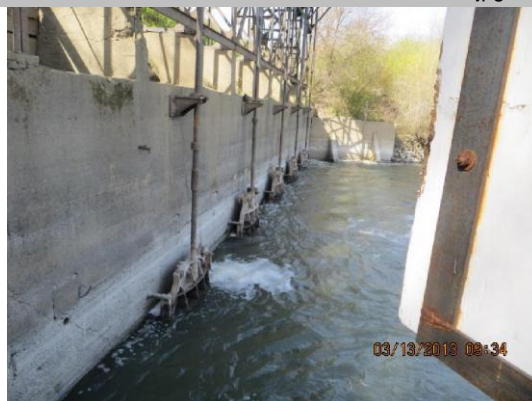
Photo 1 of 3 : UCIP_FA_2018_10164_17345.jpg

Slide gates at concrete headwall at river

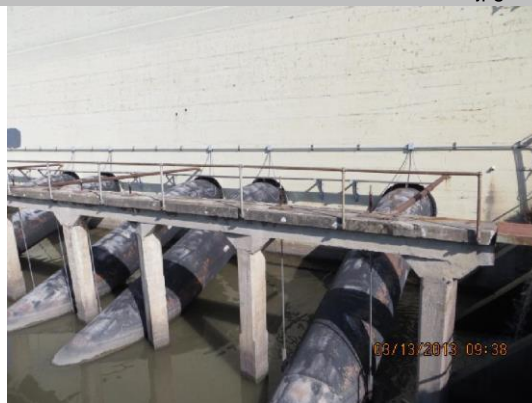
Photo 2 of 3 : UCIP_FA_2018_10164_17344.jpg

Pipes at entrance to pumping plant building on LS toe.

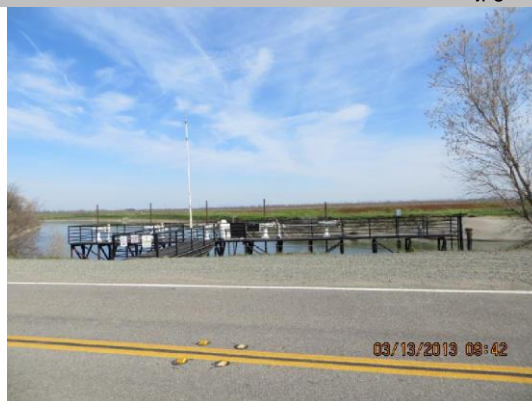
Photo 3 of 3 : UCIP_FA_2018_10164_17343.jpg

LM Start	9.75	Rating **	A/W	Issue No.	1567 (cont)	
LM End	9.75	Issue Type +	Ma	Location *		
Category	Supplemental			GPS Latitude/Longitude		
				Start	End	
Item	DWR UCIP LMA Responsibility			38.862615 °	38.862615 °	
				-121.792582 °	-121.792582 °	
DWR ID	20232					
Comment Code						
Inspector Comment						
FS_ID:10164						
DS_ID:20232						
EP_NO: N/A						
Repair Type: No Action Needed						
Crossing Status: Found						
UCIP Comments:						
FIELD_STRUCT_DESC: 1 of 5: 60-inch reinforced concrete drainage culvert through the levee, 35 feet below the crown. Screw gates on walkway at waterside (WS) shoulder. Staff gauge to 47.0 feet on structure. [Additional Reference(s): DWR Levee Log, 2006. USACE Sacramento O&M Manual 130, May 1960 (HLM 9.87)].						
FS Date: 3/13/2013

Slide gate actuators on WS shoulder.

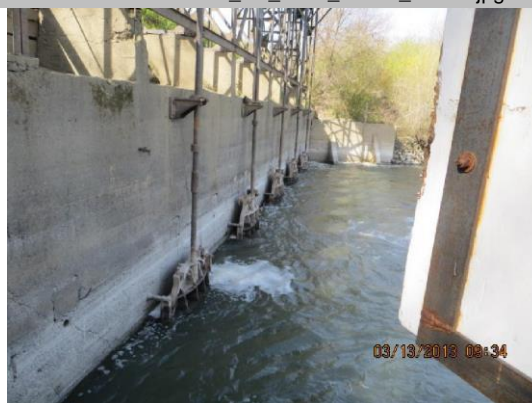
Photo 1 of 3 : UCIP_FA_2018_10165_17348.jpg

LM Start	9.76	Rating **	A/W	Issue No.	1568	
LM End	9.76	Issue Type +	Ma	Location *		
Category	Supplemental			GPS Latitude/Longitude		
				Start	End	
Item	DWR UCIP LMA Responsibility			38.862624 °	38.862624 °	
				-121.792626 °	-121.792626 °	
DWR ID	20364					
Comment Code						
Inspector Comment						
FS_ID:10165 DS_ID:20364 EP_NO: N/A Repair Type: No Action Needed Crossing Status: Found UCIP Comments: FIELD_STRUCT_DESC: 2 of 5: 60-inch reinforced concrete drainage culvert through the levee, 35 feet below the crown. Screw gate actuators on metal platform on the waterside (WS) shoulder. Large pumping plant building on the landside (LS) shoulder. Staff gauge to 47 feet on structure. [Additional Reference(s): DWR Levee Log, 2006. USACE Sacramento O&M Manual 130, May 1960 (HLM 9.87)]. FS Date: 3/13/2013

Slide gates and headwall on WS toe.

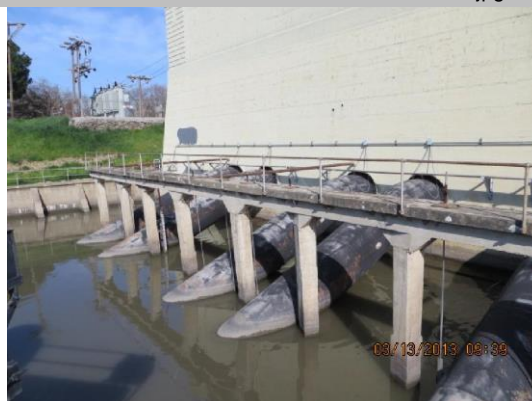
Photo 2 of 3 : UCIP_FA_2018_10165_17347.jpg

LM Start	9.76	Rating **	A/W	Issue No.	1568 (cont)
LM End	9.76	Issue Type +	Ma	Location *	
Category	Supplemental			GPS Latitude/Longitude	
				Start	End
Item	DWR UCIP LMA Responsibility			38.862624 °	38.862624 °
				-121.792626 °	-121.792626 °
DWR ID	20364				
Comment Code					
Inspector Comment					
FS_ID:10165 DS_ID:20364 EP_NO: N/A Repair Type: No Action Needed Crossing Status: Found UCIP Comments: FIELD_STRUCT_DESC: 2 of 5: 60-inch reinforced concrete drainage culvert through the levee, 35 feet below the crown. Screw gate actuators on metal platform on the waterside (WS) shoulder. Large pumping plant building on the landside (LS) shoulder. Staff gauge to 47 feet on structure. [Additional Reference(s): DWR Levee Log, 2006. USACE Sacramento O&M Manual 130, May 1960 (HLM 9.87)]. FS Date: 3/13/2013

Pipes at inlet to pumphouse on LS toe.

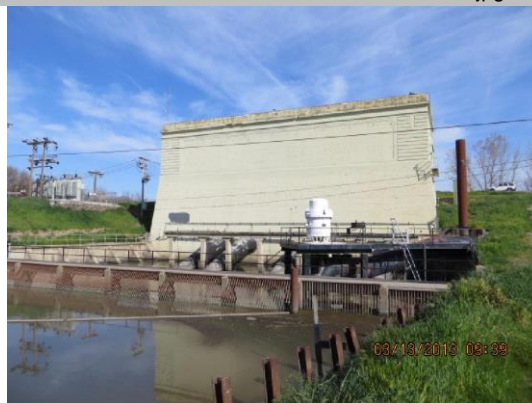
Photo 3 of 3 : UCIP_FA_2018_10165_17346.jpg

Pumphouse on LS.

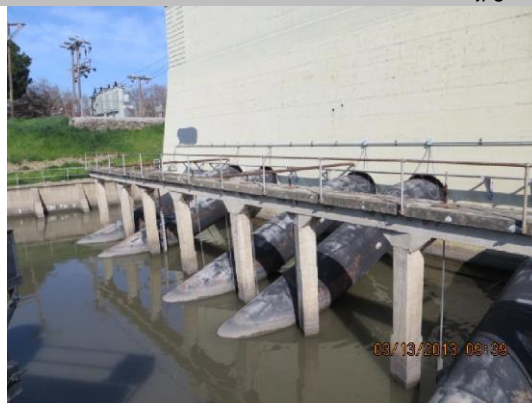
Photo 2 of 3 : UCIP_FA_2018_10168_17359.jpg

LM Start	9.76	Rating **	A/W	Issue No.	1569
LM End	9.76	Issue Type +	Ma	Location *	
Category	Supplemental			GPS Latitude/Longitude	
				Start	End
Item	DWR UCIP LMA Responsibility			38.862633 °	38.862633 °
				-121.792669 °	-121.792669 °
DWR ID	20365				
Comment Code					
Inspector Comment					
FS_ID:10168 DS_ID:20365 EP_NO: N/A Repair Type: No Action Needed Crossing Status: Found UCIP Comments: FIELD_STRUCT_DESC: 3 of 5: 60-inch reinforced concrete drainage culvert through the levee, 35 feet below the crown. Screw gate actuators on metal platform on the waterside (WS) shoulder. Large pumping plant building on the landside (LS) shoulder. Staff gauge to 47 feet on structure. [Additional Reference(s): DWR Levee Log, 2006. USACE Sacramento O&M Manual 130, May 1960 (HLM 9.87)]. FS Date: 3/13/2013

Pipe at inlet to pumphouse on LS toe.

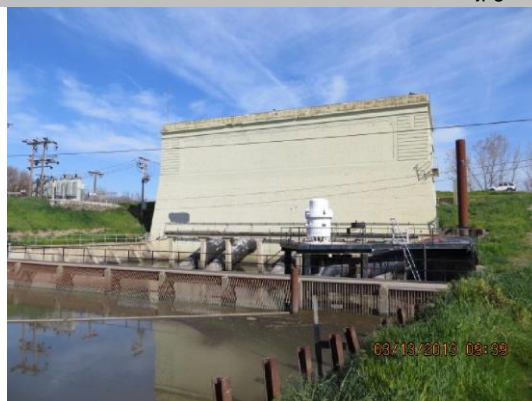
Photo 3 of 3 : UCIP_FA_2018_10168_17358.jpg

LM Start	9.76	Rating **	A/W	Issue No.	1569 (cont)
LM End	9.76	Issue Type +	Ma	Location *	
Category	Supplemental			GPS Latitude/Longitude	
				Start	End
Item	DWR UCIP LMA Responsibility			38.862633 °	38.862633 °
				-121.792669 °	-121.792669 °
DWR ID	20365				
Comment Code					
Inspector Comment					
FS_ID:10168 DS_ID:20365 EP_NO: N/A Repair Type: No Action Needed Crossing Status: Found UCIP Comments: FIELD_STRUCT_DESC: 3 of 5: 60-inch reinforced concrete drainage culvert through the levee, 35 feet below the crown. Screw gate actuators on metal platform on the waterside (WS) shoulder. Large pumping plant building on the landside (LS) shoulder. Staff gauge to 47 feet on structure. [Additional Reference(s): DWR Levee Log, 2006. USACE Sacramento O&M Manual 130, May 1960 (HLM 9.87)]. FS Date: 3/13/2013

Pumphouse on LS.

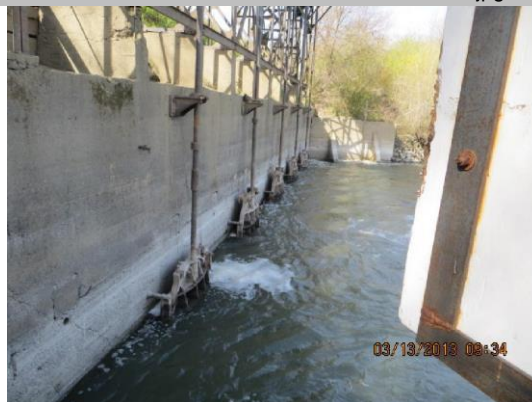
Photo 1 of 3 : UCIP_FA_2018_10167_17352.jpg

LM Start	9.76	Rating **	A/W	Issue No.	1570
LM End	9.76	Issue Type +	Ma	Location *	
Category	Supplemental			GPS Latitude/Longitude	
				Start	End
Item	DWR UCIP LMA Responsibility			38.862642 °	38.862642 °
				-121.792713 °	-121.792713 °
DWR ID	20366				
Comment Code					
Inspector Comment					
FS_ID:10167 DS_ID:20366 EP_NO: N/A Repair Type: No Action Needed Crossing Status: Found UCIP Comments: FIELD_STRUCT_DESC: 4 of 5: 60-inch reinforced concrete drainage culvert through the levee, 35 feet below the crown. Screw gate actuators on metal platform on the waterside (WS) shoulder. Large pumping plant building on the landside (LS) shoulder. Staff gauge to 47 feet on structure. [Additional Reference(s): DWR Levee Log, 2006. USACE Sacramento O&M Manual 130, May 1960 (HLM 9.87)]. FS Date: 3/13/2013

Slide gates and headwall at WS toe.

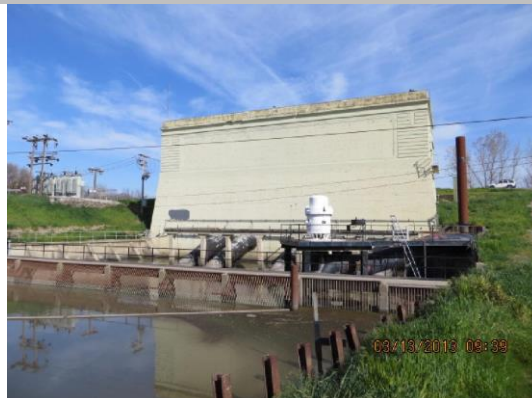
Photo 3 of 3 : UCIP_FA_2018_10169_17362.jpg

LM Start	9.76	Rating **	A/W	Issue No.	1571 (cont)
LM End	9.76	Issue Type +	Ma	Location *	
Category	Supplemental			GPS Latitude/Longitude	
				Start	End
Item	DWR UCIP LMA Responsibility			38.862650 °	38.862650 °
				-121.792754 °	-121.792754 °
DWR ID	20367				
Comment Code					
Inspector Comment					
FS_ID:10169 DS_ID:20367 EP_NO: N/A Repair Type: No Action Needed Crossing Status: Found UCIP Comments: FIELD_STRUCT_DESC: 5 of 5: 60-inch reinforced concrete drainage culvert through the levee, 35 feet below the crown. Screw gate actuators on metal platform on the waterside (WS) shoulder. Large pumping plant building on the landside (LS) shoulder. Staff gauge to 47 feet on structure. [Additional Reference(s): DWR Levee Log, 2006. USACE Sacramento O&M Manual 130, May 1960 (HLM 9.87)]. FS Date: 3/13/2013

Pumphouse on LS.

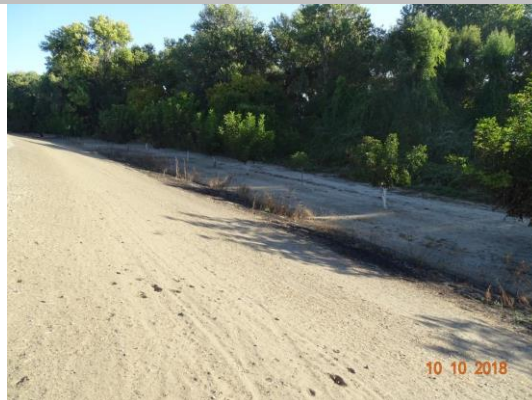
Photo 1 of 1 : FA_2018_NA0016_435_106_20181011_00228.jpg

LM Start	10.66	Rating **	M	Issue No.	106
LM End	10.80	Issue Type +	En	Location *	WS
Category	Earthen Levee			GPS Latitude/Longitude	
				Start	End
Item	Encroachments			38.866474 °	38.868426 °
				-121.803711 °	-121.803732 °
DWR ID	DWR_NA0016_01_f_2018_106				
Comment Code					
CR : Crops					
Inspector Comment					
Walnut orchard on the waterside berm.

View of walnut orchard on the waterside berm. Fall 2018.

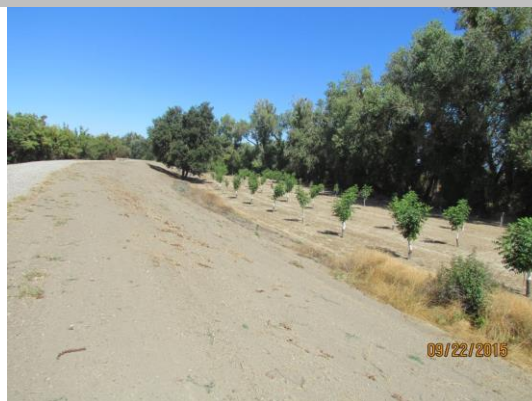
Photo 1 of 1 : FA_2018_NA0016_435_966_20180904_00056.jpg

LM Start	11.65	Rating **	M	Issue No.	966
LM End	11.76	Issue Type +	En	Location *	WS
Category	Earthen Levee			GPS Latitude/Longitude	
				Start	End
Item	Encroachments			38.876088 °	38.877491 °
				-121.815459 °	-121.816356 °
DWR ID	DWR_NA0016_01_s_2012_966				
Comment Code					
CR : Crops					
Inspector Comment					
New walnut orchard between toe and river with approximately 80-90 trees.

View of the walnut orchard planted on the waterward side of the levee looking upstream. Fall 2015.

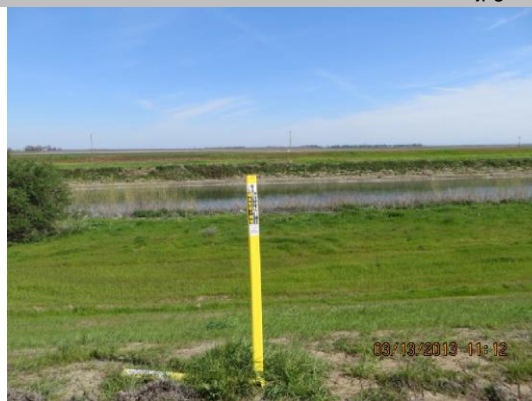
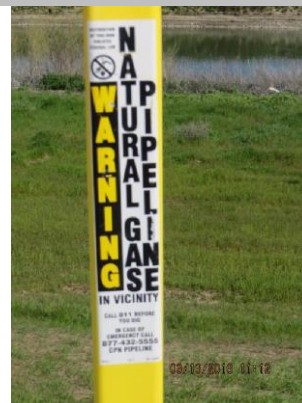
LM Start	16.22	Rating **	M	Issue No.	1572	
LM End	16.22	Issue Type +	En	Location *		
Category	Supplemental			GPS Latitude/Longitude		
				Start	End	
Item	DWR UCIP Field Study			38.923407 °	38.923407 °	
				-121.834588 °	-121.834588 °	
DWR ID	20432					
Comment Code						
Inspector Comment						
FS_ID:10203						
DS_ID:20432						
EP_NO: N/A						
Repair Type: Non-Urgent						
Crossing Status: Found						
UCIP Comments: Need to determine if this is a permitted crossing as it was not previously noted. Need to determine size and depth below the crown.						
FIELD_STRUCT_DESC: Gas line of an unknown material and diameter through the levee, at an unknown depth. Marker on waterside (WS) shoulder.						
FS Date: 3/13/2013

Gasline marker on WS shoulder.

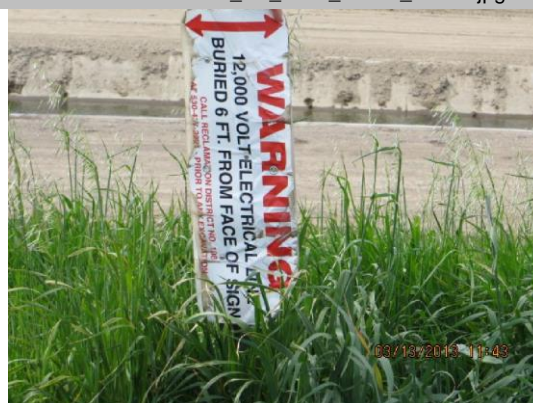
Photo 1 of 1 : UCIP_FA_2018_11323_18720.jpg

LM Start	17.94	Rating **	M	Issue No.	1573
LM End	17.94	Issue Type +	En	Location *	
Category	Supplemental			GPS Latitude/Longitude	
				Start	End
Item	DWR UCIP Field Study			38.942979 °	38.942979 °
				-121.837030 °	-121.837030 °
DWR ID	22957				
Comment Code					
Inspector Comment					
FS_ID:11323					
DS_ID:22957					
EP_NO: 18026					
Repair Type: Non-Urgent					
Crossing Status: Found					
UCIP Comments: Conduit needs to be located and signs installed where it crosses the levee crown.					
FIELD_STRUCT_DESC: Electrical conduit of an unknown material and diameter through the levee, at an unknown depth. Signage on the landside (LS) shoulder. (Permit No. 18026, 2006 - Reclamation District No. 108).					
FS Date: 3/13/2013

Sign on LS shoulder.

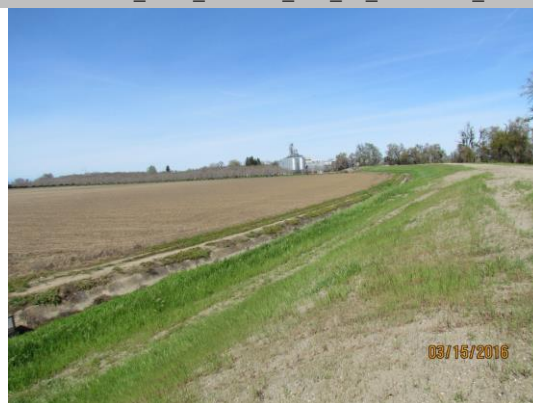
Photo 1 of 1 : FA_2018_NA0016_435_15_20180904_00003.jpg

LM Start	18.20	Rating **	M	Issue No.	15
LM End	18.46	Issue Type +	En	Location *	LS
Category	Earthen Levee			GPS Latitude/Longitude	
				Start	End
Item	Encroachments			38.946674 °	38.950263 °
				-121.837528 °	-121.837768 °
DWR ID	DWR_NA0016_01_s_2012_15				
Comment Code					
DT : Ditch					
Inspector Comment					
Concrete lined ditch runs along the toe of the levee.

View of the ditch on the landward side of the levee looking upstream.
Spring 2016.

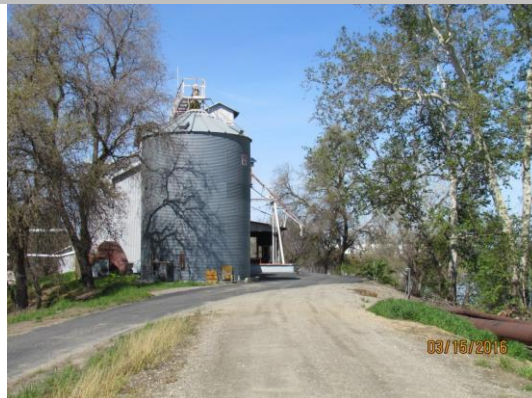
Photo 1 of 1 : FA_2018_NA0016_435_16_20180904_00004.jpg

LM Start	18.54	Rating **	M	Issue No.	16
LM End	18.54	Issue Type +	En	Location *	CR
Category	Earthen Levee			GPS Latitude/Longitude	
				Start	End
Item	Encroachments			38.951400 °	38.951400 °
				-121.838255 °	-121.838255 °
DWR ID	DWR_NA0016_01_f_2018_16				
Comment Code					
BU : Building					
Inspector Comment

View of the rice mill on the crown of the levee looking upstream. Spring 2016.

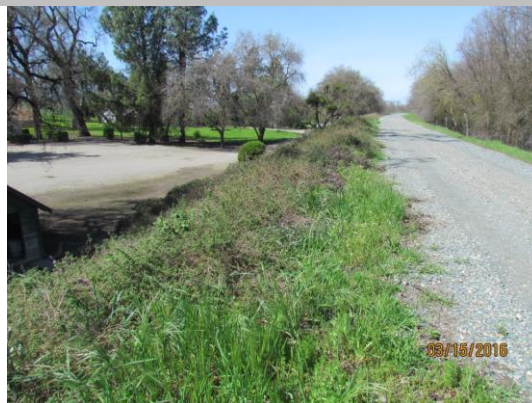
Photo 1 of 2 : FA_2018_NA0016_435_173_20180904_00049.jpg

LM Start	18.66	Rating **	M	Issue No.	173
LM End	18.70	Issue Type +	En	Location *	LS
Category	Earthen Levee			GPS Latitude/Longitude	
				Start	End
Item	Vegetation			38.952765 °	38.953219 °
				-121.839661 °	-121.840199 °
DWR ID	DWR_NA0016_01_s_2016_173				
Comment Code					
V6 : Landscaping					
Inspector Comment					
Permit number 16487. Owner needs to maintain/trim vegetation.

View of the landscaping on the landward side of the levee looking upstream. Spring 2016.

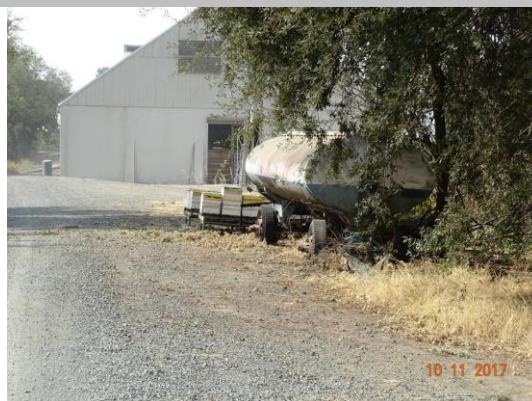
Photo 1 of 2 : FA_2018_NA0016_435_26_20180904_00005.jpg

LM Start	19.12	Rating **	M	Issue No.	26
LM End	19.12	Issue Type +	En	Location *	LS
Category	Earthen Levee			GPS Latitude/Longitude	
				Start	End
Item	Encroachments			38.957180 °	38.957180 °
				-121.837442 °	-121.837442 °
DWR ID	DWR_NA0016_01_s_2012_26				
Comment Code					
EQ : Equipment					
Inspector Comment					
Beehives and tank on landside slope.

Updated view of equipment and beehives. Fall 2017.

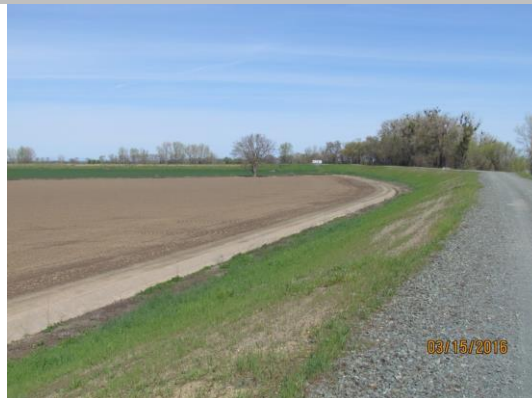
Photo 1 of 2 : FA_2018_NA0016_435_31_20180904_00011.jpg

LM Start	19.15	Rating **	M	Issue No.	31
LM End	19.61	Issue Type +	En	Location *	LS
Category	Earthen Levee			GPS Latitude/Longitude	
				Start	End
Item	Encroachments			38.957405 °	38.962648 °
				-121.836965 °	-121.834368 °
DWR ID	DWR_NA0016_01_s_2012_31				
Comment Code					
DT : Ditch					
Inspector Comment					
Concrete lined ditch up to LM 19.40. Soil ditch continues on until LM 19.61.

View of the ditch on the landward side of the levee looking upstream. Spring 2016.

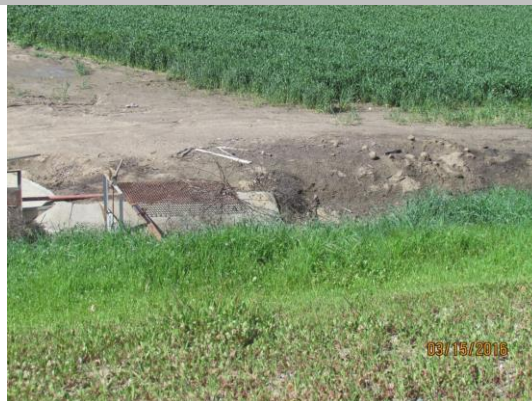
Photo 2 of 2 : FA_2018_NA0016_435_31_20180904_00012.jpg

Concrete lined ditch stops at levee mile 19.40.

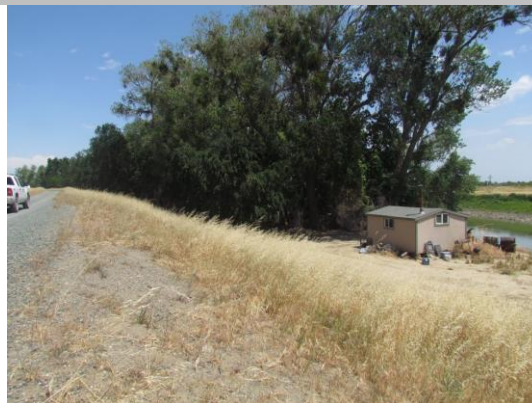
Photo 1 of 1 : FA_2018_NA0016_435_96_20180904_00022.jpg

LM Start	19.37	Rating **	M	Issue No.	96
LM End	19.37	Issue Type +	En	Location *	WS
Category	Earthen Levee			GPS Latitude/Longitude	
				Start	End
Item	Encroachments			38.959642°	38.959642°
				-121.834004°	-121.834004°
DWR ID	DWR_NA0016_01_s_2015_96				
Comment Code					
BU : Building					
Inspector Comment

View of the building on the waterward side of the levee looking upstream. Spring 2015.

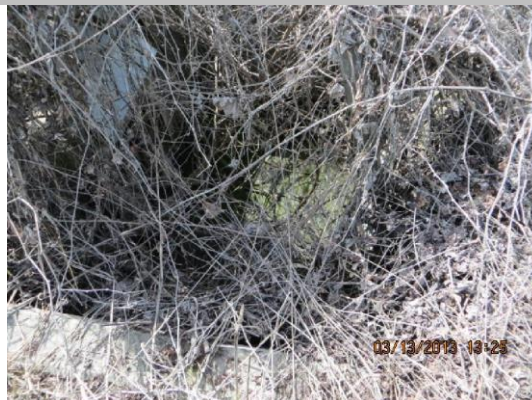
Photo 2 of 2 : UCIP_FA_2018_10253_17448.jpg

Concrete distribution box under heavy blackberry cover at LS toe.

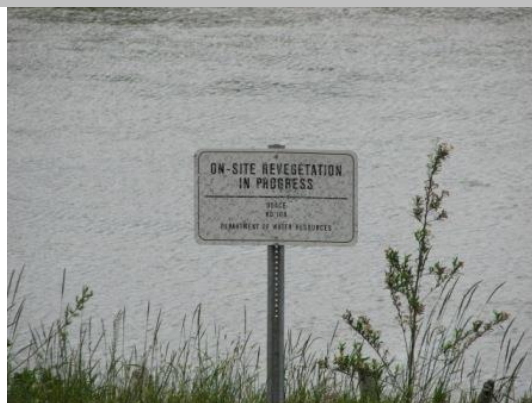
Photo 1 of 2 : FA_2018_NA0016_435_30_20180904_00009.jpg

LM Start	22.12	Rating **	A/W	Issue No.	30
LM End	22.42	Issue Type +	Ob	Location *	WS
Category	Earthen Levee			GPS Latitude/Longitude	
				Start	End
Item	Vegetation			38.989528 °	38.989722 °
				-121.816020 °	-121.810488 °
DWR ID	DWR_NA0016_01_f_2018_30				
Comment Code					
V8 : Environmental Requirements.					
Inspector Comment

Revegetation site. Photo taken spring 2012.

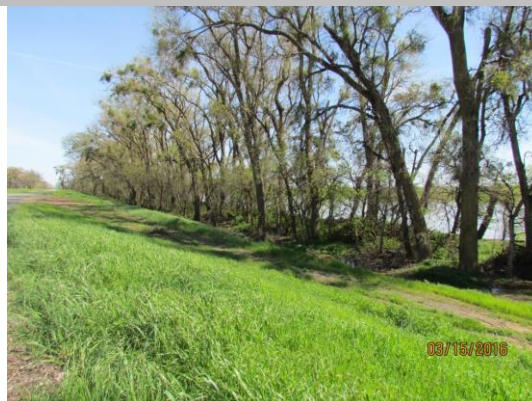
Photo 2 of 2 : FA_2018_NA0016_435_30_20180904_00010.jpg

View of the revegetation on the waterward berm of the levee looking upstream. Spring 2016.

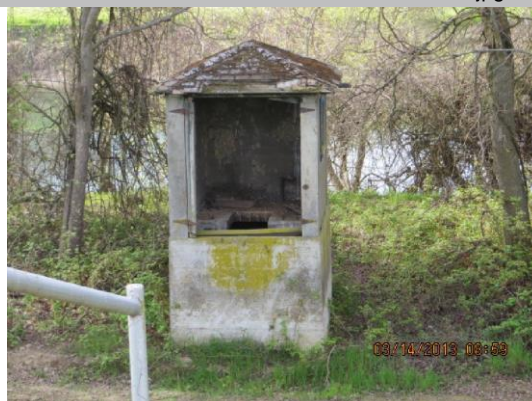
Photo 1 of 2 : UCIP_FA_2018_10266_17490.jpg

LM Start	22.71	Rating **	M	Issue No.	1575	
LM End	22.71	Issue Type +	En	Location *		
Category	Supplemental			GPS Latitude/Longitude		
				Start	End	
Item	DWR UCIP Field Study			38.989862 °	38.989862 °	
				-121.805243 °	-121.805243 °	
DWR ID	20248					
Comment Code						
Inspector Comment						
FS_ID:10266						
DS_ID:20248						
EP_NO: N/A						
Repair Type: Non-Urgent						
Crossing Status: Found						
UCIP Comments: Pipe needs to be verified as having been properly abandoned.						
FIELD_STRUCT_DESC: 24-inch irrigation pipe of an unknown material through the levee, 19.5 feet below the crown. Abandoned concrete pump house on the waterside (WS) toe. [Additional Reference(s): USACE Sacramento O&M Manual 130, May 1960 (HLM 22.99)].						
FS Date: 3/14/2013

Concrete pumphouse on WS berm.

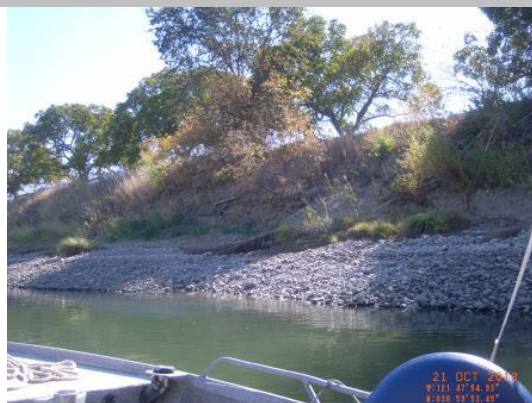
Photo 1 of 1 : FA_2018_NA0016_435_86_20181023_00231.jpg

LM Start	23.55	Rating **	A/W	Issue No.	86
LM End	23.65	Issue Type +	Ma	Location *	WS
Category	Supplemental			GPS Latitude/Longitude	
				Start	End
Item	2017 USACE Erosion Survey, DRAFT			38.997696 °	38.998336 °
				-121.797584 °	-121.799298 °
DWR ID	DWR_NA0016_01_f_2018_86				
Comment Code					
Inspector Comment					
2017 Site ID: SAC 115.9 R Status: Eroding 2017 Field Notes: No observed change. Site History: 2008 - Slippage of cobbles off hard underlying toe material. 2011 - Minor slumping site. 2012 - Failing cobble site, site extended upstream. 2016 - New erosion pockets. DWR Inspector Comment: Cobble shelf within the water. There is a large section of berm. Does not appear to be actively eroding. Recommend monitoring.

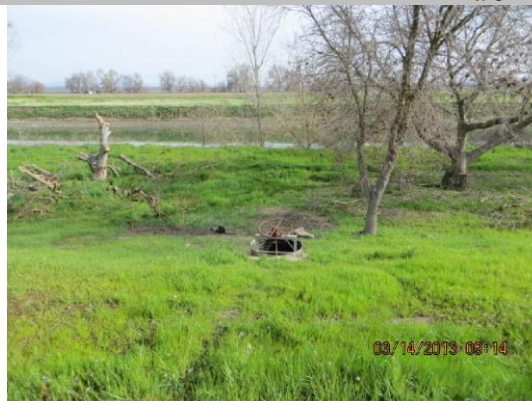
Photo 1 of 3 : UCIP_FA_2018_10261_17466.jpg

Comment Code					
Inspector Comment					
FS_ID:10261 DS_ID:20249 EP_NO: 9374 Repair Type: Non-Urgent Crossing Status: Found UCIP Comments: Appears abandoned. Pipe should be properly abandoned. FIELD_STRUCT_DESC: 1 of 4: 36-inch corrugated metal irrigation pipe through the levee, 20 feet below the crown. One corrugated metal cutoff wall installed by the United States Army Corp of Engineers, 1955. Slide gate inside a 36-inch corrugated metal riser unit on the waterside (WS) slope. Pump on the WS bank. Concrete standpipe on the landside (LS) toe. (Automatic Board Order (ABO) issued as Permit No. 9374, 1974 - Richard H. Moore). [Additional Reference(s): USACE Sacramento O&M Manual 130, May 1960 (HLM 24.03)]. FS Date: 3/14/2013

36-inch cmp riser on WS slope with slide gate.

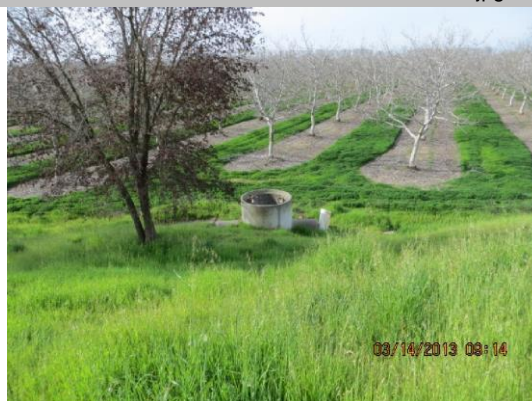
Photo 2 of 3 : UCIP_FA_2018_10261_17465.jpg

Concrete distribution riser on LS toe.

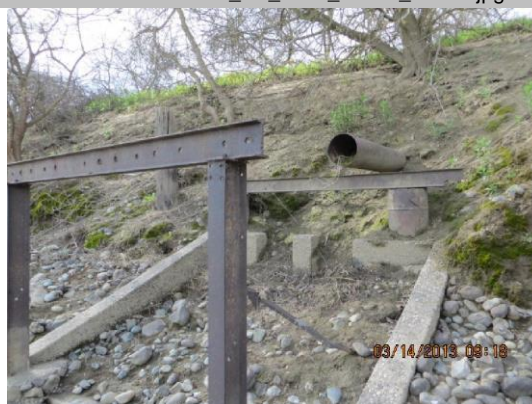
Photo 3 of 3 : UCIP_FA_2018_10261_17464.jpg

abandoned pump platform on Rivers edge.

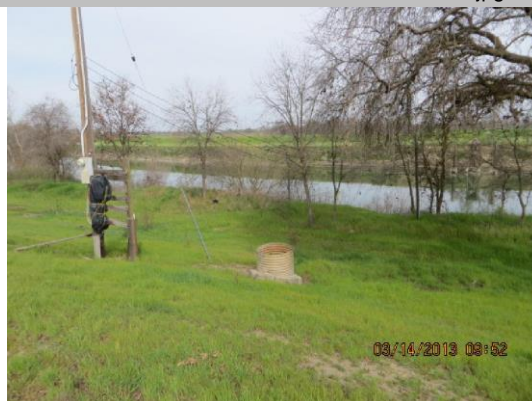
Photo 1 of 2 : UCIP_FA_2018_10265_17486.jpg

Comment Code						
Inspector Comment						
FS_ID:10265						
DS_ID:20251						
EP_NO: 9328						
Repair Type: Non-Urgent						
Crossing Status: Found						
UCIP Comments: Appears abandoned. Needs to be abandoned properly.						
FIELD_STRUCT_DESC: 24-inch corrugated metal irrigation pipe through the levee, 20 feet below the crown. Slide gate inside a 36-inch corrugated metal riser unit on the waterside (WS) slope. 7-foot by 9-foot distribution box at the toe of the landside (LS) slope. (Automatic Board Order (ABO) issued as Permit No. 9328, 1974 - Wayne A. Hine).						
[Additional Reference(s): DWR Levee Log, 2006. USACE Sacramento O&M Manual 130, May 1960 (HLM 25.02)].						
FS Date: 3/14/2013

Slide gate in 36-inch CMP riser on WS slope.

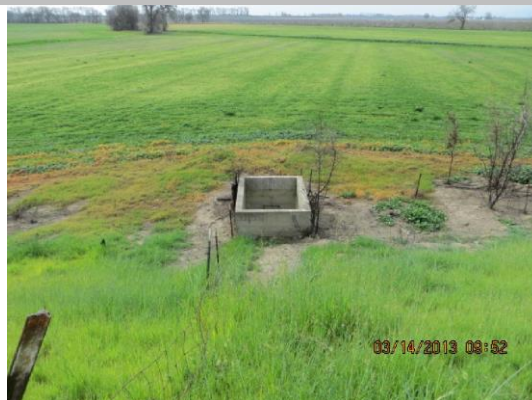
Photo 2 of 2 : UCIP_FA_2018_10265_17485.jpg

7-foot by 9-foot distribution box at LS toe.

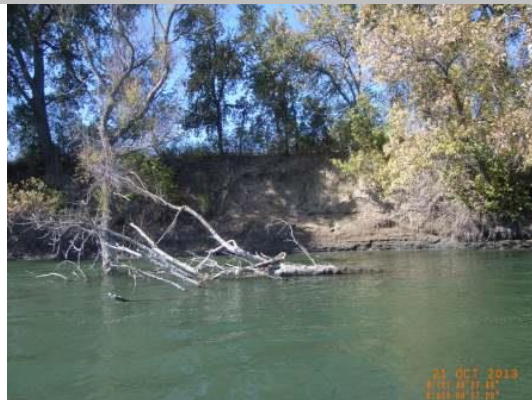
Photo 1 of 1 : FA_2018_NA0016_435_88_20181023_00232.jpg

LM Start	25.75	Rating **	A/W	Issue No.	88
LM End	25.91	Issue Type +	Ma	Location *	WS
Category	Supplemental			GPS Latitude/Longitude	
				Start	End
Item	2017 USACE Erosion Survey, DRAFT			39.014499 °	39.016401 °
				-121.825880 °	-121.824230 °
DWR ID	DWR_NA0016_01_f_2018_88				
Comment Code					
Inspector Comment					
2017 Site ID: SAC 118.0 R					
Status: Eroding					
2017 Field Notes: No observed change.					
Site History: 2008 - Whole bank is eroding, nearly vertical slope with cohesive toe. Bed is very deep along the toe (greater than 30 ft deep at 20 ft from the shore). 2011 - Some new minor erosion. 2016 - Minor new erosion.

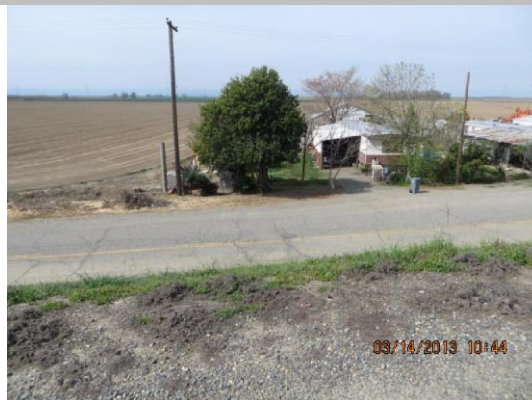
Photo 1 of 3 : UCIP_FA_2018_10285_17532.jpg

LM Start	26.46	Rating **	M	Issue No.	1578
LM End	26.46	Issue Type +	En	Location *	
Category	Supplemental			GPS Latitude/Longitude	
				Start	End
Item	DWR UCIP Field Study			39.023842 °	39.023842 °
				-121.823077 °	-121.823077 °
DWR ID	20253				
Comment Code					
Inspector Comment					
FS_ID:10285 DS_ID:20253 EP_NO: 9136 Repair Type: Non-Urgent Crossing Status: Found UCIP Comments: Pipe appears to be abandoned. Pipe needs to be abandoned properly. FIELD_STRUCT_DESC: *ABANDONED* 18-inch coated steel drainage pipe through the levee, 3 feet below the crown. Steel cutoff wall at the centerline. Air release valve on the waterside (WS) shoulder. Slide gate inside a 72-inch diameter corrugated metal riser unit on the landside (LS) toe. (Permit No. 9136, 1973 - Durst Brothers). [Additional Reference(s): DWR Levee Log, 2006]. FS Date: 3/14/2013

72-inch CMP riser on LS toe under JP next to tree.

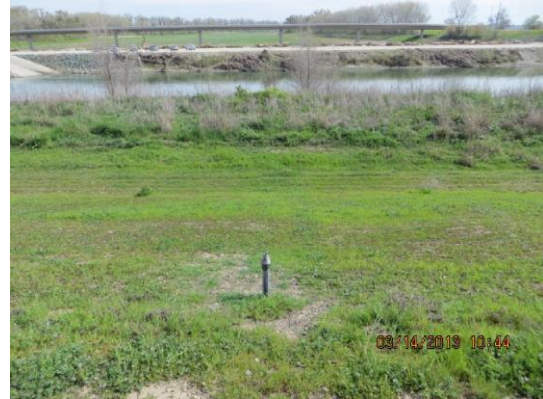
Photo 2 of 3 : UCIP_FA_2018_10285_17531.jpg

Air release valve on WS shoulder.

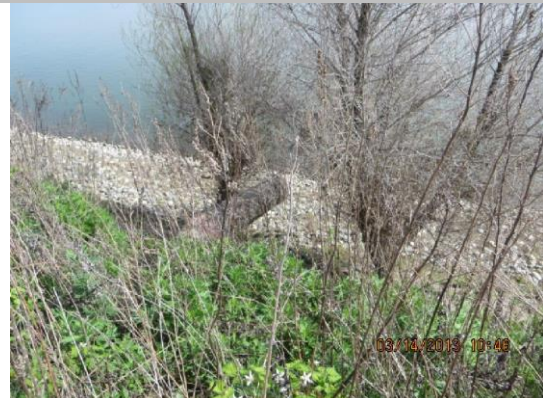
Photo 3 of 3 : UCIP_FA_2018_10285_17534.jpg

Pipe at Rivers edge.

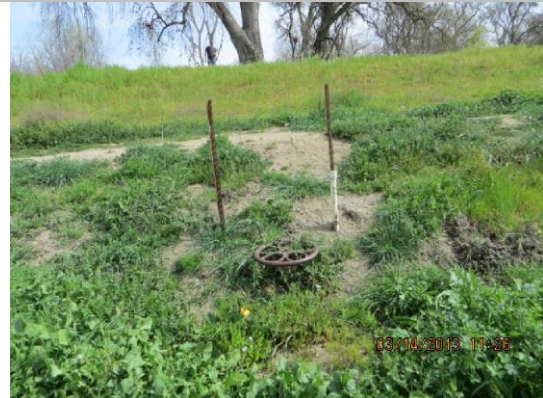
Photo 1 of 2 : UCIP_FA_2018_10289_17543.jpg

Comment Code						
Inspector Comment						
FS_ID:10289 DS_ID:20256 EP_NO: 9368 Repair Type: Non-Urgent Crossing Status: Found UCIP Comments: Need to abandon pipe properly. FIELD_STRUCT_DESC: 24-inch steel irrigation pipe through the levee, 16.2 feet below the crown. Pump on the waterside (WS) bank. Gate valve on the landside (LS) end. Concrete box at the LS toe of the slope. Irrigation well 6 feet from the toe of the landward slope. (Automatic Board Order (ABO) issued as Permit No. 9368, 1974 - Fredinand Erdman). [Additional Reference(s): DWR Levee Log, 2006. USACE Sacramento O&M Manual 131, May 1960 (HLM 27.79) (standpipe on the WS)]. FS Date: 3/14/2013

gate valve off landside toe.

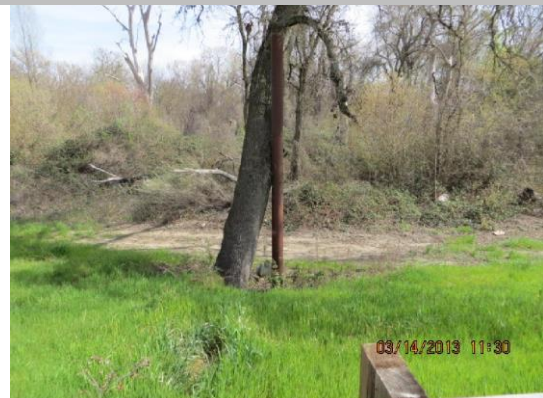
Photo 2 of 2 : UCIP_FA_2018_10289_17542.jpg

steel standpipe on WS toe.

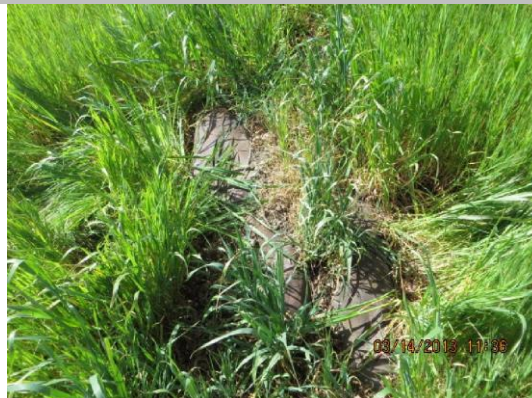
Photo 1 of 2 : UCIP_FA_2018_10290_17545.jpg

FS_ID:10290
DS_ID:20416
EP_NO: N/A
Repair Type: Non-Urgent
Crossing Status: Indicator Found

Pipe debris on WS slope.

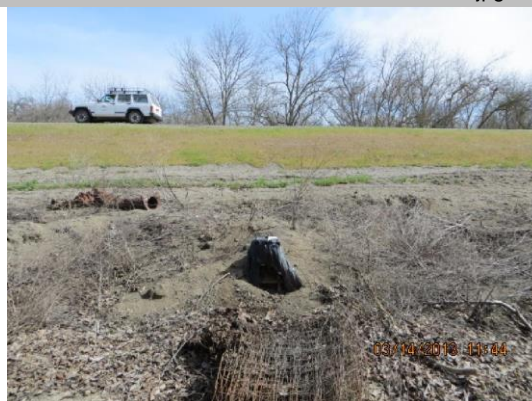
Photo 1 of 3 : UCIP_FA_2018_10291_17548.jpg

LM Start	27.54	Rating **	M	Issue No.	1581
LM End	27.54	Issue Type +	Ma	Location *	
Category	Supplemental			GPS Latitude/Longitude	
				Start	End
Item	DWR UCIP LMA Responsibility			39.034870 °	39.034870 °
				-121.833501 °	-121.833501 °
DWR ID	20257				
Comment Code					
Inspector Comment					
FS_ID:10291 DS_ID:20257 EP_NO: 9355 Repair Type: Non-Urgent Crossing Status: Found UCIP Comments: Pipe needs to be properly abandoned. FIELD_STRUCT_DESC: *ABANDONED* 24-inch steel drainage pipe through the levee, 14 feet below the crown. Slide gate on the waterside (WS) end. Gate valve on the landside (LS) end. (24-inch pipe [HLM 27.89] authorized under Automatic Board Order (ABO) issued as Permit No. 9355, 1974 - Alvin Gustafson). [Additional Reference(s): DWR Levee Log, 2006. USACE Sacramento O&M Manual 131, May 1960 (HLM 27.89)]. FS Date: 3/14/2013

Gate valve buried on LS toe.

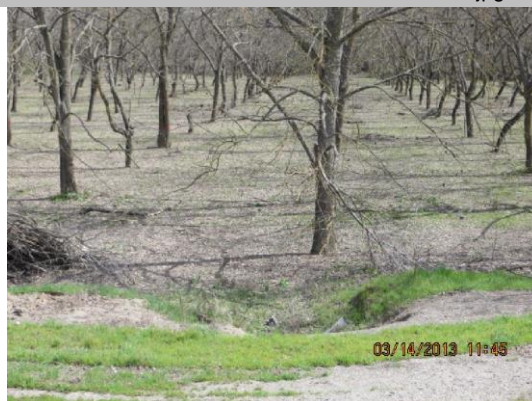
Photo 3 of 3 : UCIP_FA_2018_10291_17546.jpg

Excavation at WS toe where pipe should be.

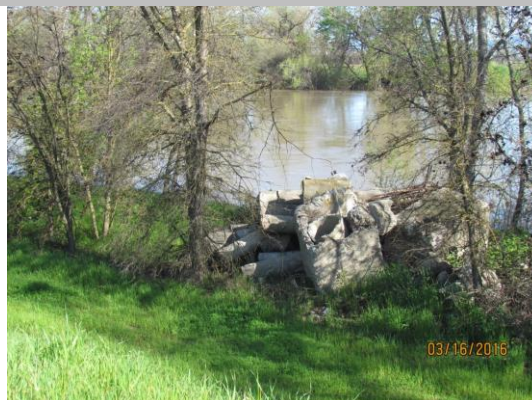
Photo 1 of 1 : FA_2018_NA0016_435_59_20180904_00018.jpg

LM Start	28.02	Rating **	M	Issue No.	59
LM End	28.02	Issue Type +	En	Location *	WS
Category	Earthen Levee			GPS Latitude/Longitude	
				Start	End
Item	Encroachments			39.040750 °	39.040750 °
				-121.835299 °	-121.835299 °
DWR ID	DWR_NA0016_01_s_2012_59				
Comment Code					
DE : Debris					
Inspector Comment					
piles of concrete

View of the pile of concrete on the waterward berm of the levee. Spring 2016.

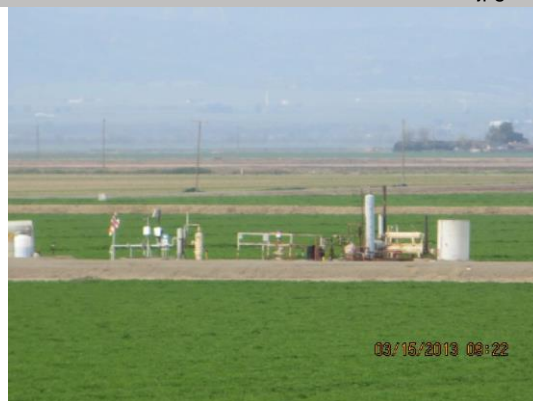
Photo 1 of 1 : UCIP_FA_2018_49833_17563.jpg

Comment Code						
Inspector Comment						
FS_ID:49833 DS_ID:20319 EP_NO: 16632 Repair Type: Non-Urgent Crossing Status: Indicator Found UCIP Comments: 09/01/2016 - No markers on levee. no condition in permit for markers. Pipe is well underneath the levee prism with minimum clearance under the river of 35 feet per permit drawings. (T. Hatch/UCIP) 03/15/2013 No gasline markers on either side of levee. (W. Wylie/UCIP) FIELD_STRUCT_DESC: 4-inch welded steel natural gas pipeline through the levee, 62 feet below the crown. Crosses under both levees and the Sacramento River channel with a minimum clearance of 35 feet. Gas well visible approximately 1,500 feet west of the levee on the landside (LS). (Permit No. 16632, 1997 - Slawson Exploration Company, Inc./AA Production Services, Inc.). FS Date: 9/1/2016

gas well 1500-feet west of this location.

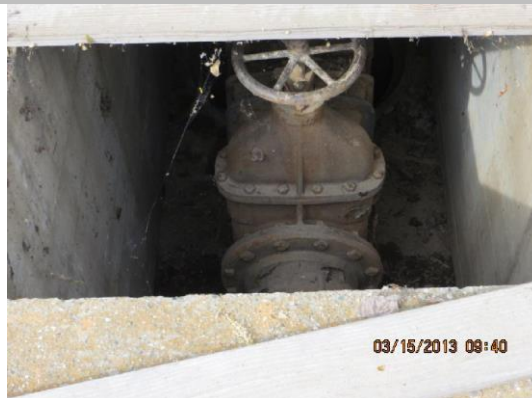
Photo 1 of 3 : UCIP_FA_2018_10306_17566.jpg

Comment Code					
Inspector Comment					
FS_ID:10306					
DS_ID:20341					
EP_NO: 9358					
Repair Type: No Action Needed					
Crossing Status: Found					
UCIP Comments:					
FIELD_STRUCT_DESC: 16-inch steel drainage pipe through the levee, 8.5 feet below the crown. Siphon breaker inside a 24-inch corrugated metal riser unit on the waterside (WS) slope. Pump inside pump house on the landside (LS). Overhead power line crosses the levee. Pole on the LS shoulder. (one 12-inch, one 16-inch, and one 24-inch pipes [HLM 29.02] authorized under Automatic Board Order (ABO) issued as Permit No. 9358, 1974 - Crocker National Bank (Trustee)). [Additional Reference(s): DWR Levee Log, 2006. USACE Sacramento O&M Manual 131, May 1960 (HLM 29.02)].					
FS Date: 3/15/2013

Gate valve under pumphouse on LS toe.
